Separator failure Report Rev. #2 – 18.01.2003 ABC Fire Compressor

- Separator Failure Report -

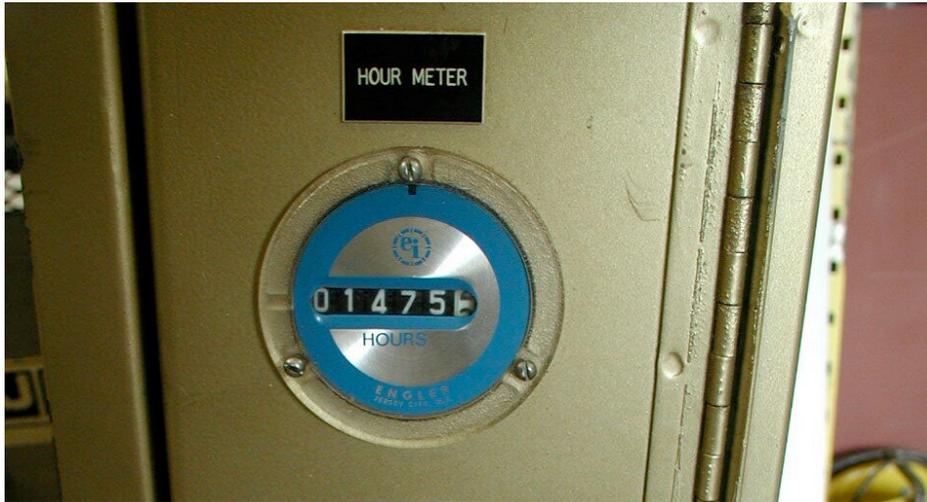
COMPRESSOR HOUR METER

The K14 compressor had been sold a number of times and was purchased as a used unit. The current owner Mr. Don Crawford of ABC Fire was not aware of a safety directive sent out over 12 years ago warning of possible failure of the “Type 1” oil and water separators. The compressor was produced in 1984 and according to the hour meter reading had reached 1475 operating hours.

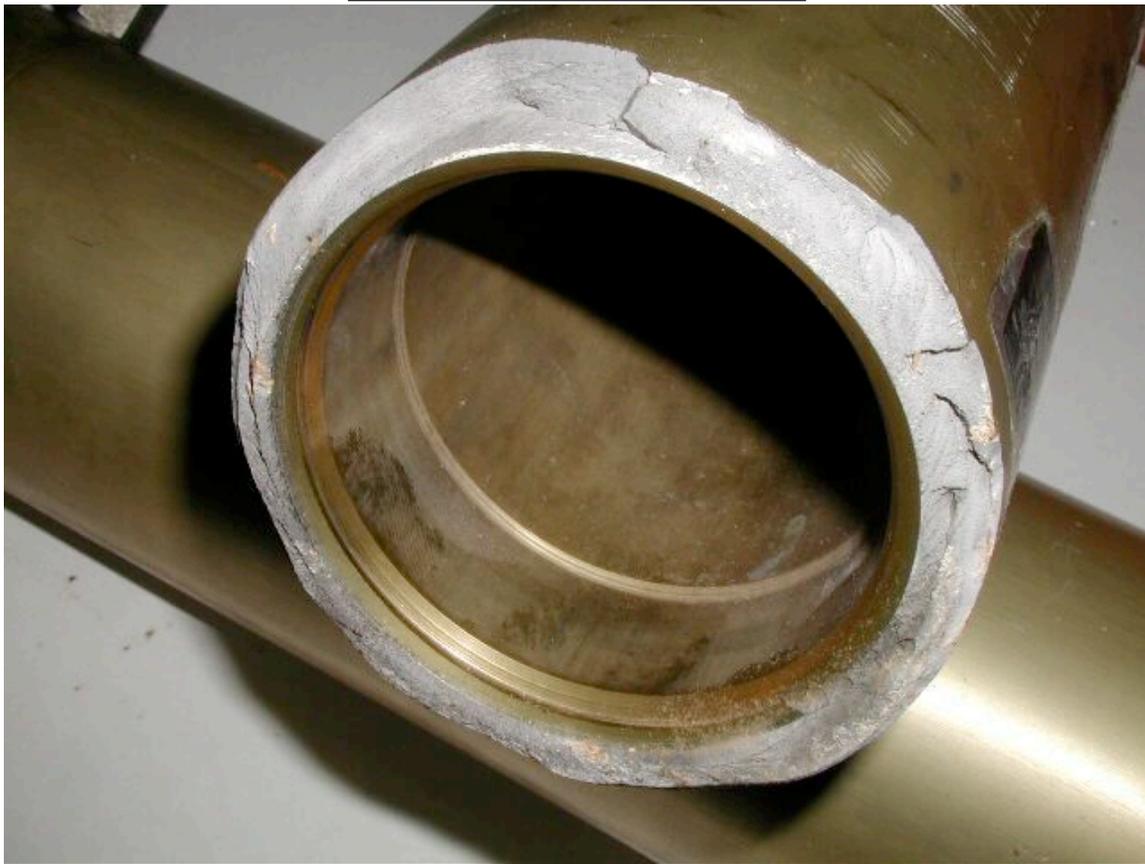
In June 2002 at ABC Fire Extinguisher Co. in Saskatoon, Saskatchewan a “Type 1” 7075-T6-aluminium alloy final oil and water failed during the filling of a high-pressure storage cascade to 5000 PSIG. The separator barrel failed at the inner most thread and the barrel separated from the lower cap. The barrel and top cap proceeded upwards with great force through a pair of 2” x 8” ceiling joist and then impacted into a steel roof truss.

FAILED SEPARATOR BARREL

Jordair offers ASME code design engineered separators with CRN (Canadian Boiler and Pressure Vessels Registration) to replace any questionable units in service. It is illegal in Canada to operate a compressor system that has unregistered pressure components that do not have CRN numbers.
